Garber Laboratories, Inc.

December 22, 2011

Re: Project Number 11-417, Failure Analysis of a 2 7/8-Inch L-80 Production Tubing
Location: South Bayou Malett Field, Thibodeaux Lease, Well # 1

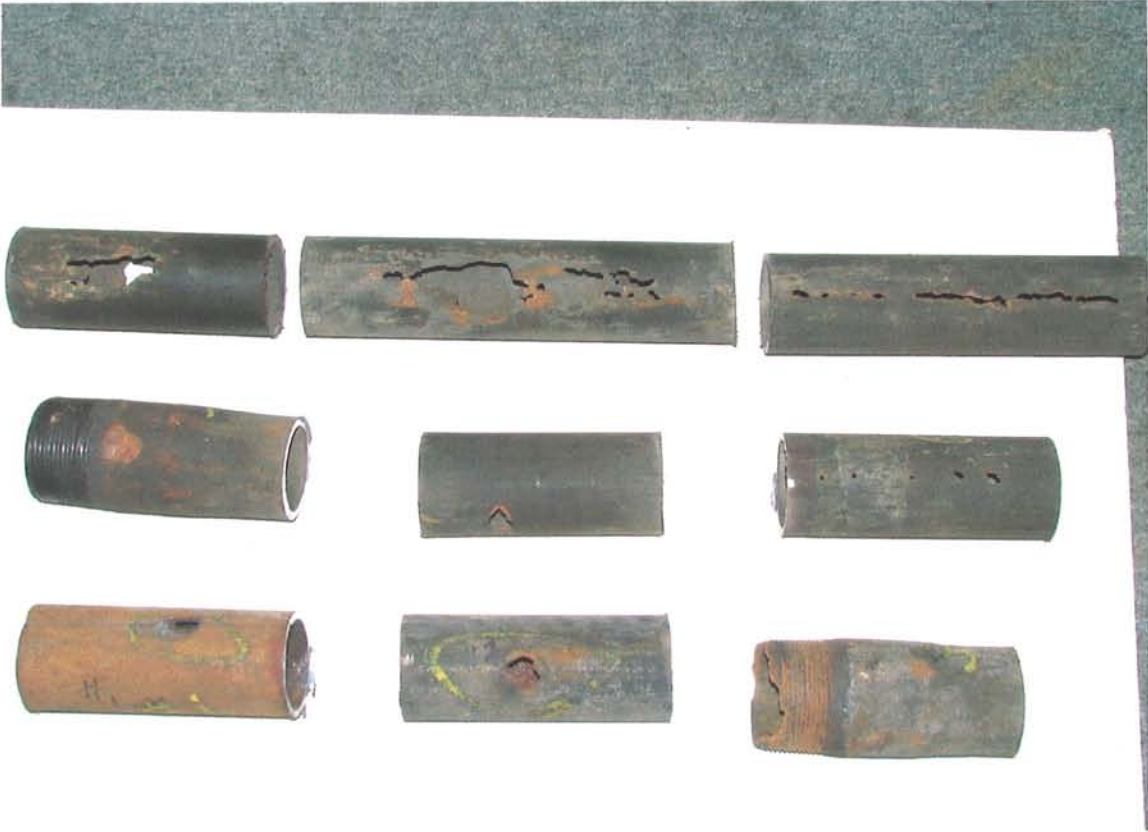
A total of nine sections of the tubing and two gas lift mandrels were received for examination. Figure 1 shows the nine sections of the tubing and Figure 2 shows the two gas lift mandrels. The tubing sections were from various depths in the well ranging from 500 feet to 8,700 feet. Six of these sections were carefully examined in an attempt to determine the mechanism of the failures. These sections were from depths of 1,800, 2,900, 3,300, 5,700, 6,800 and 8,700 feet.

Figure 1
Sections of the Tubing Received for Examination

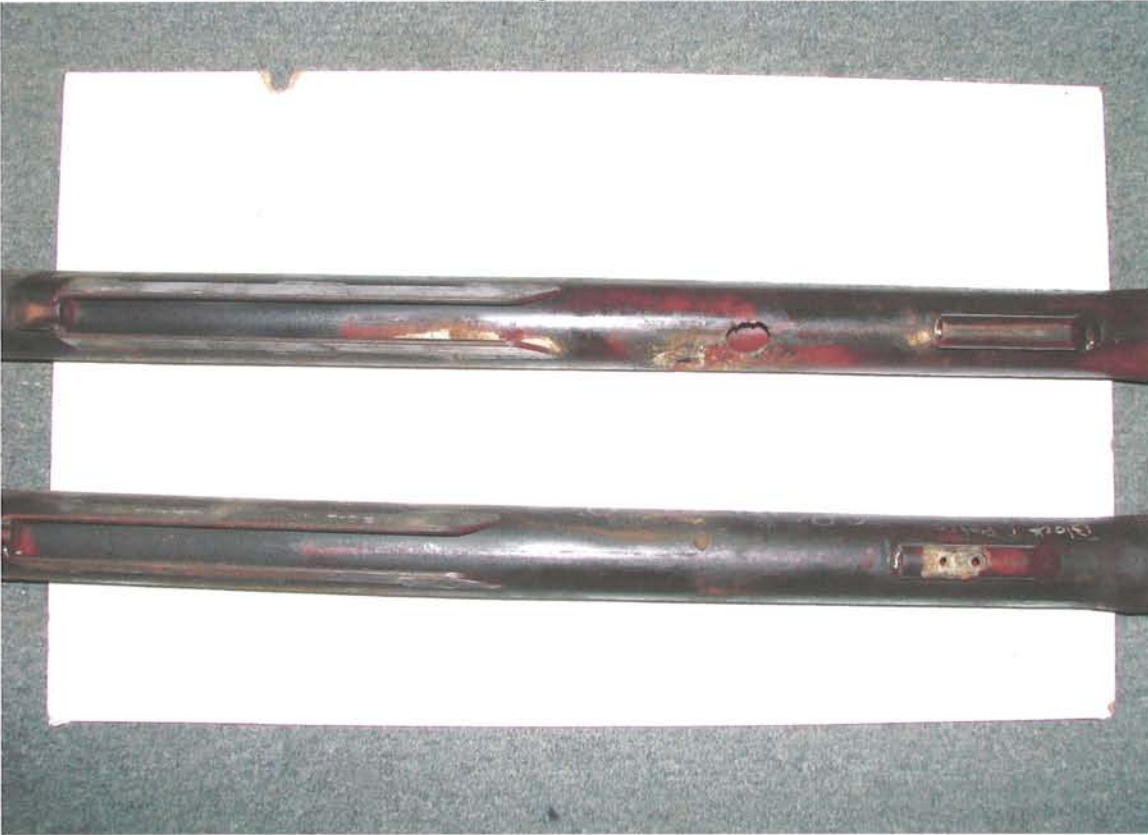
Figure 2
Gas Lift Mandrels Received for Examination

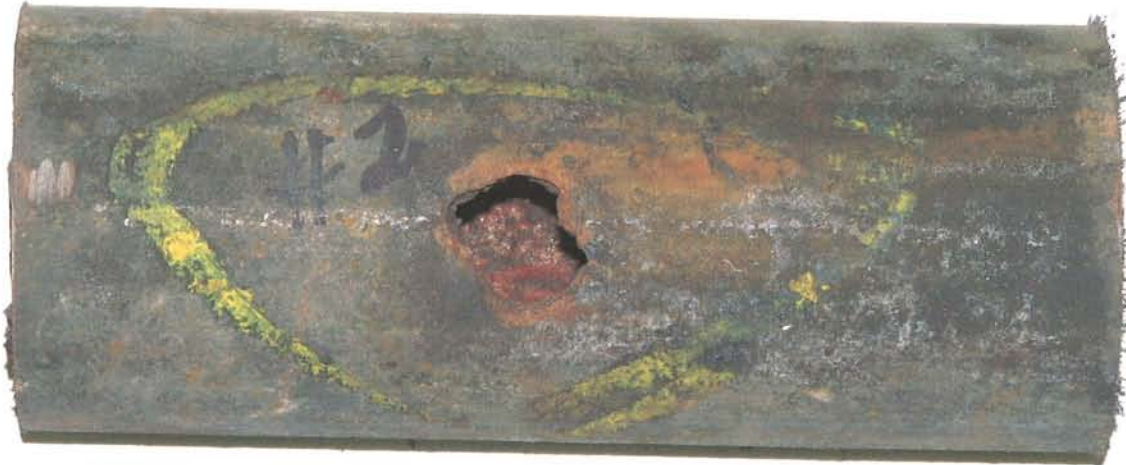
Section #2; 1,800 feet: Figure 3 shows the external surface of the section from 1,800 feet. There was a large failure site. Other than the failure site there was no evidence of external corrosion. The section was split open to facilitate an examination of the internal surface. Figure 4 shows the internal surface of the tubing. The failure was located in a trench that appeared to be from rod wear. There was also a large circular area of metal loss that was on the opposite side of the tubing from the failure site. It appeared that this metal loss was due to liquid/sand impingement that occurred after the tubing wall was penetrated. The metal surface was coated with a thin layer of dark brown scale. The scale was removed and samples were collected for further analysis. Figure 5 shows the internal surface after cleaning. There was a significant amount of corrosion around the failure site, which indicated that the corrosion had initiated from the internal surface. Figure 6 shows a closer view of the failure site. There was a line of very deep pits that appeared to be in an area where the sucker rod rubbed against the side of the tubing.

Figure 3
Section #2 from 1,800 Feet

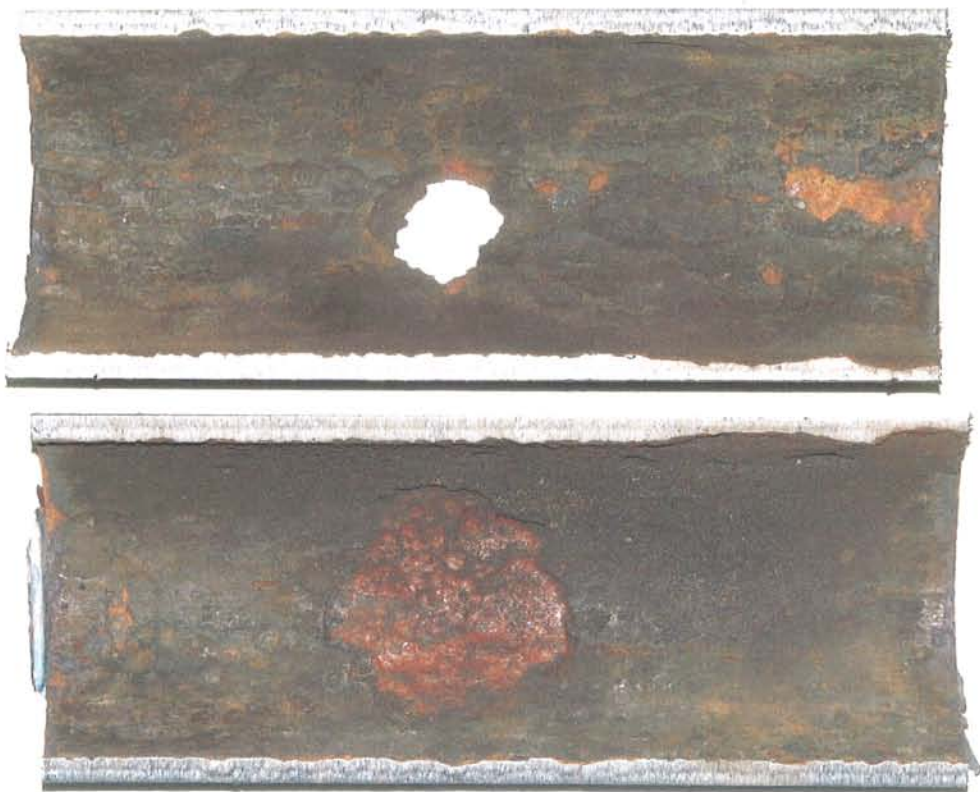
Figure 4
Internal Surface of Section #2

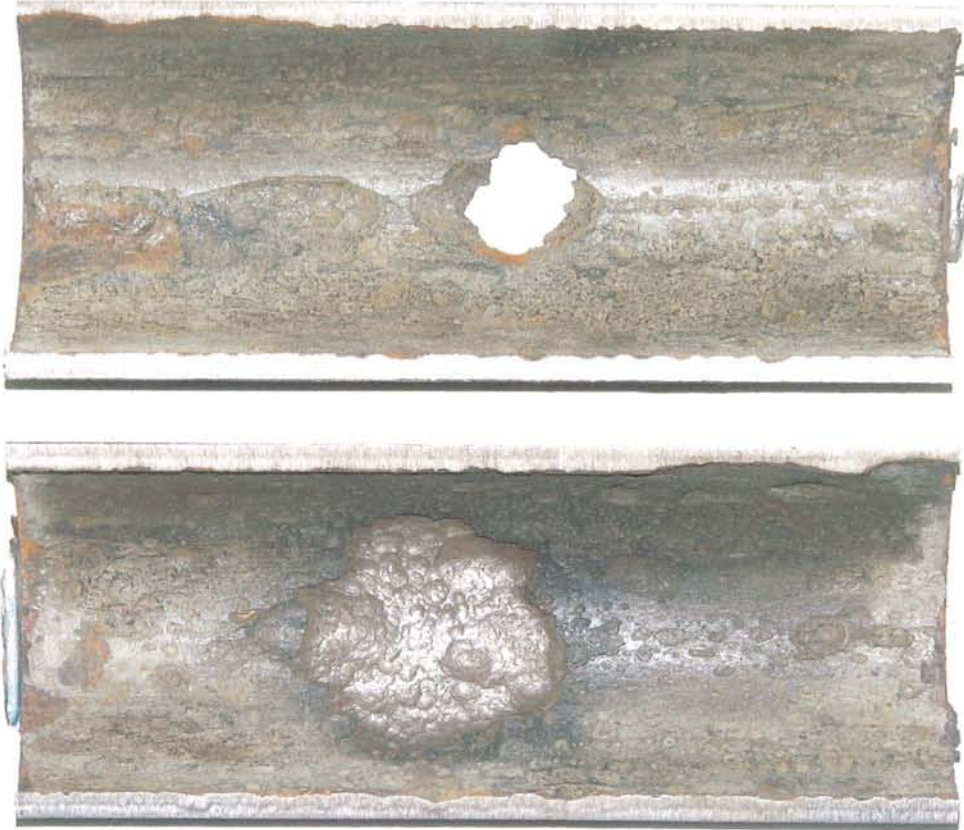
Figure 5
Internal Surface of Section #2 After Cleaning

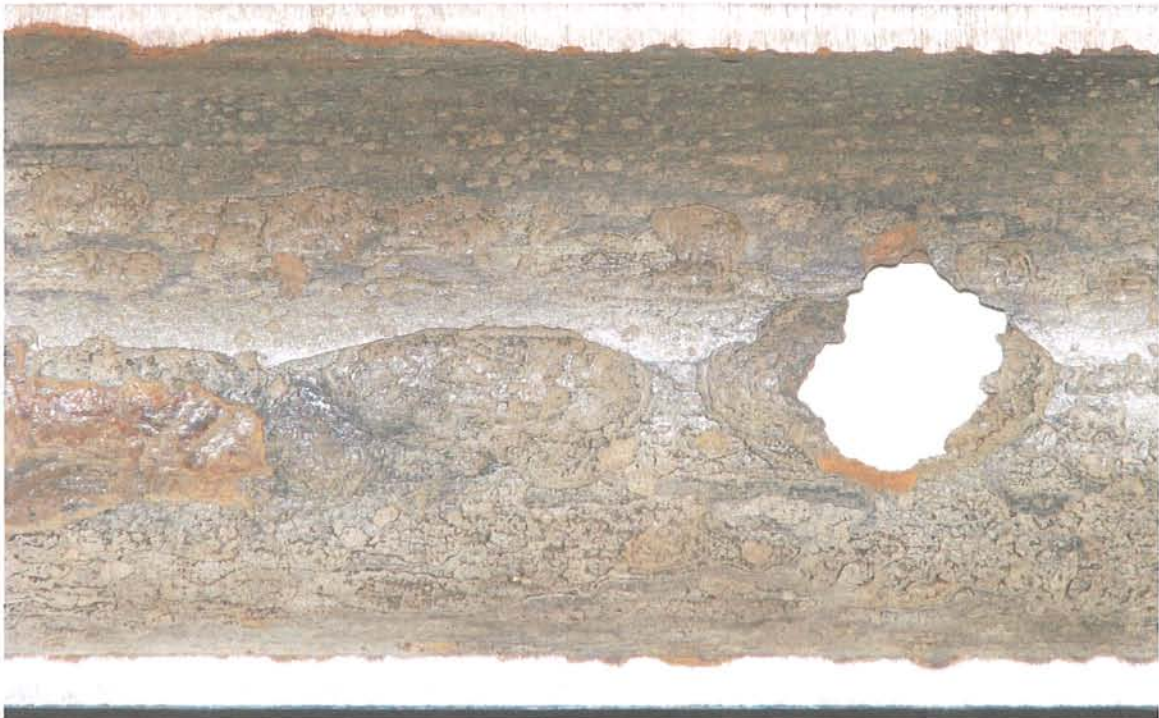
3. All of the failure sites that originated from the internal surface were associated with rod wear. It appeared that the rubbing of the rods against the tubing had removed protective scale and had cold worked the metal surface, which allowed aggressive corrosion attack to occur. The mesa morphology of the pits and the abundance of siderite in the pits were consistent with CO₂ corrosion.

Figure 6
Internal Corrosion on Section #2

1. If any of the original tubing is currently in the well, the tubing should be removed and inspected for internal and external corrosion. Any joint of tubing that has experienced cold working due to rod wear from the sucker rods should be discarded. It might be best to eliminate all of the original tubing.

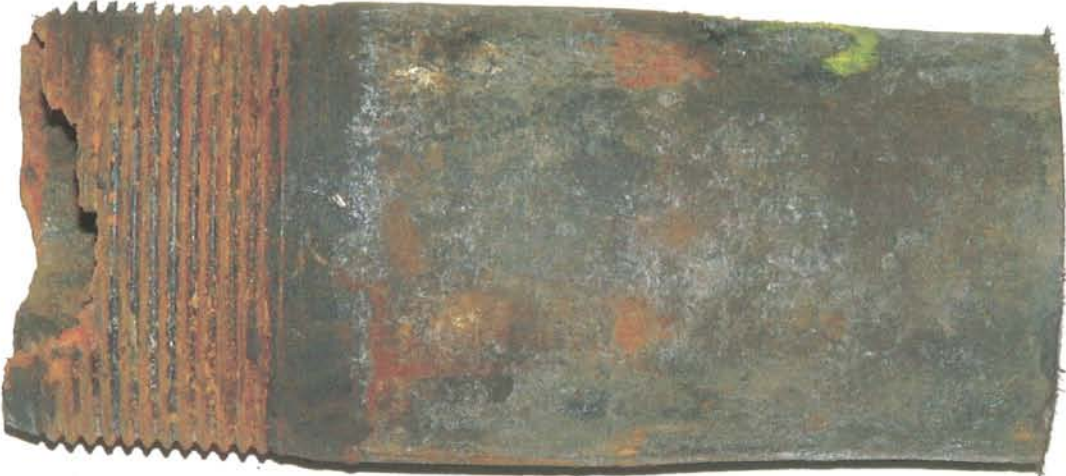
Section #3; 2,900 feet: Figure 7 shows the pin end of this section. The threads had suffered significant metal loss. The metal loss appeared to be due to impingement on the threads that were facing the direction of flow. Figure 8 shows a closer view of the threads. The amount of metal loss was significant. Other than the impingement, there was no significant internal or external corrosion on this section.

Figure 7
Section #3 from 2,900 Feet

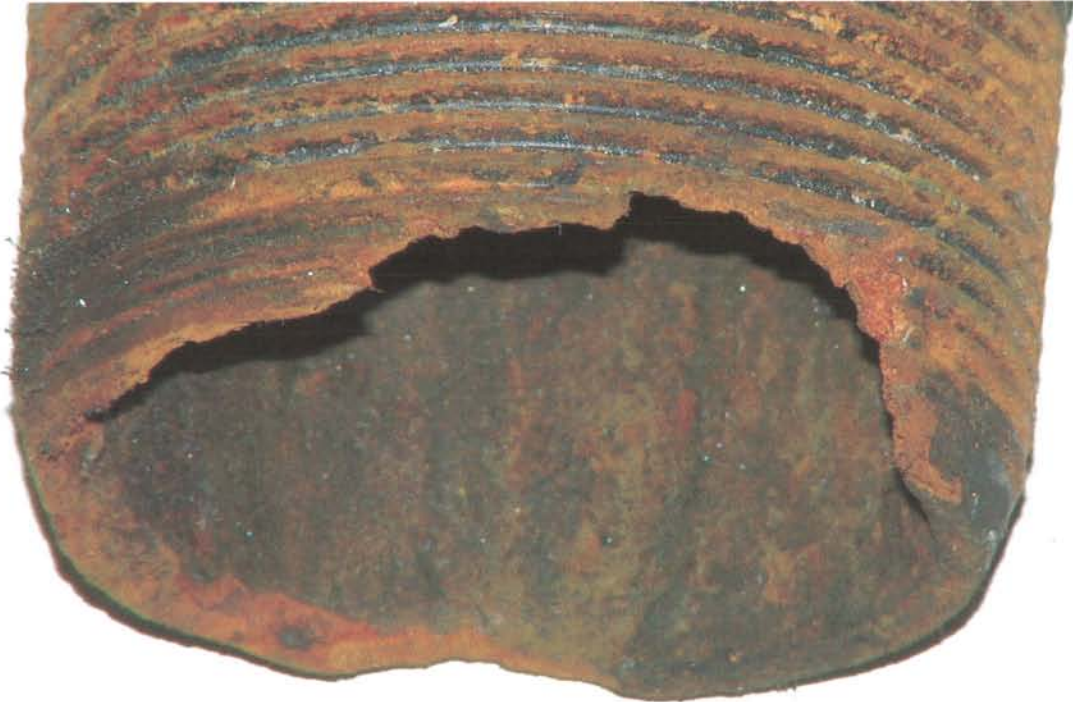
6. The pin end from 2,900 feet had suffered severe sand impingement at the leading edge of the pin. The pin end from 3,300 feet exhibited minor sand impingement. The flow dynamics calculations indicated that the sand impingement occurred after the well was converted to gas lift. The flow dynamics in the tubing before the well was converted to gas lift would not have generated the velocities needed to produce this level of metal loss.

Figure 8
Sand Impingement on Section #3

3. The problem with sand impingement has to be addressed. Eliminating the sand with sand screens or gravel packs should end this problem. If the sand cannot be eliminated, tubing collars that eliminate the gap in between the joints should be used. Either premium connectors or collars with inserts could eliminate the exposure of the leading edge of the pin.

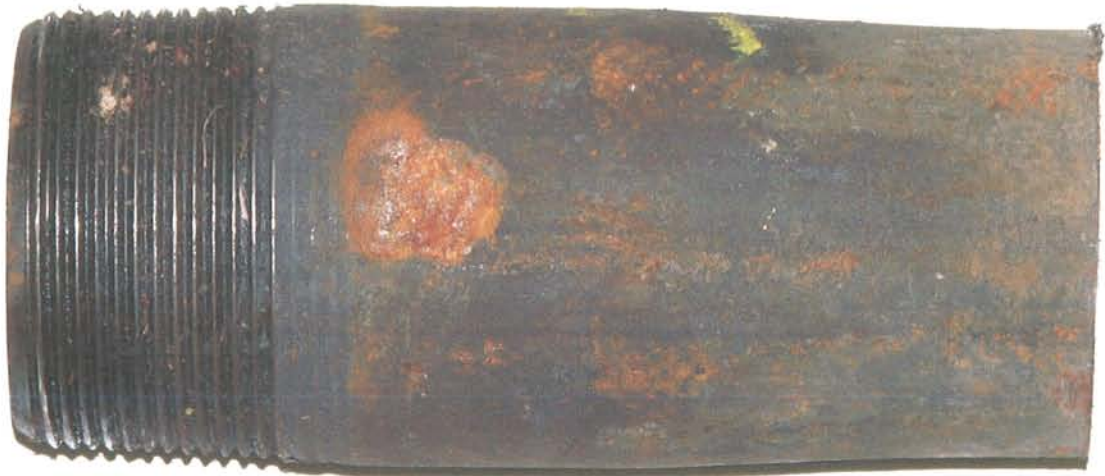
Section #4; 3,300 feet: Figure 9 shows the pin end from this section. This section had one very large and deep pit on the external surface near the threads. The pit was cleaned and Figure 10

Figure 9
Section #4 from 3,300 Feet

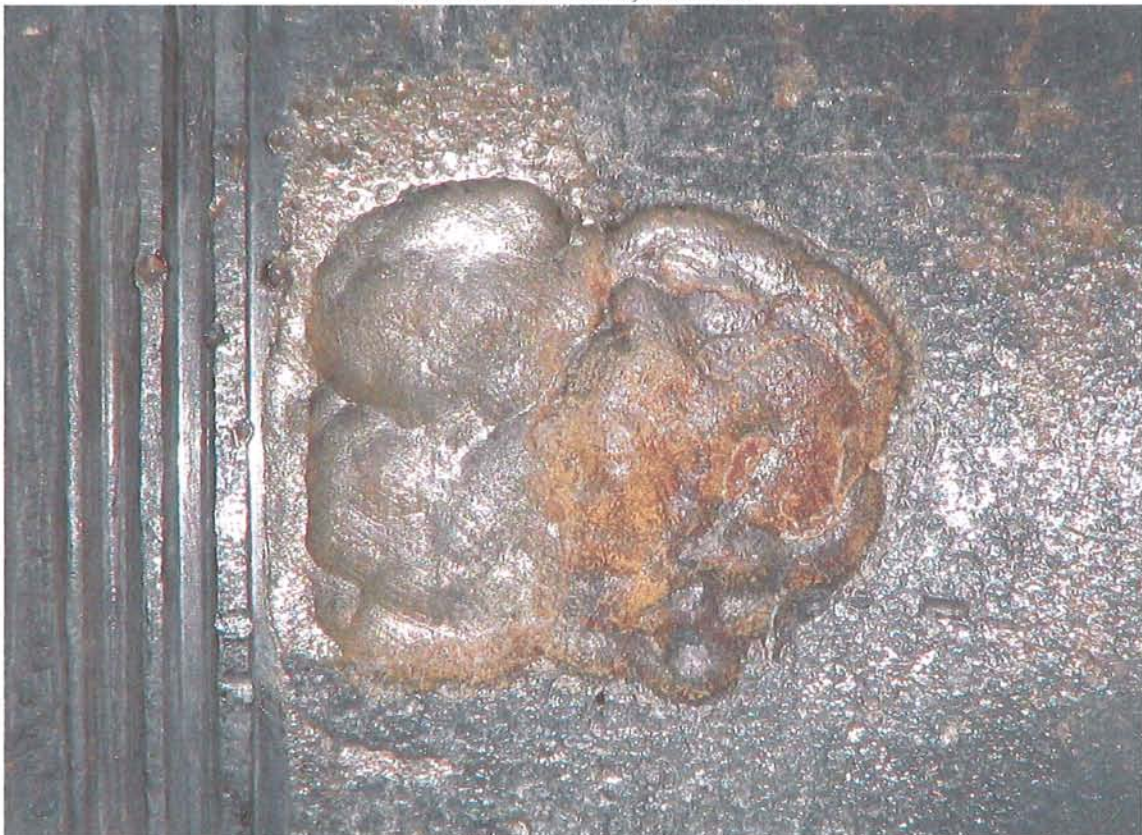
7. The pin end from 3,300 feet had also suffered external corrosion. The corrosion was one large deep pit. The morphology of this pit and the abundance of iron sulfide in the pit indicated that the corrosion was due to bacteria.

shows a closer view of the pit after cleaning. The morphology of the pit with smooth surfaces, slightly undercut edges, tiered sides, and a broad flat bottom suggested that bacteria were responsible for the corrosion. The leading edge of the threads had suffered a slight amount of impingement, but no additional internal or external corrosion was noted.

Figure 10
Close-Up of the External Corrosion on Section #4

4. The bacteria infestation in the annulus will have to be addressed. Bactericide applications should resolve this problem. Since the external corrosion due to bacteria was so aggressive, there is the possibility of corrosion damage to the internal surface of the casing. A caliper survey should be conducted on the casing to determine the integrity of the casing.
5. Replacing the L-80 tubing with corrosion resistant alloy (CRA), like chrome 13, should solve the internal corrosion problems, but the problem with sand impingement and bacteria will remain and will have to be addressed.

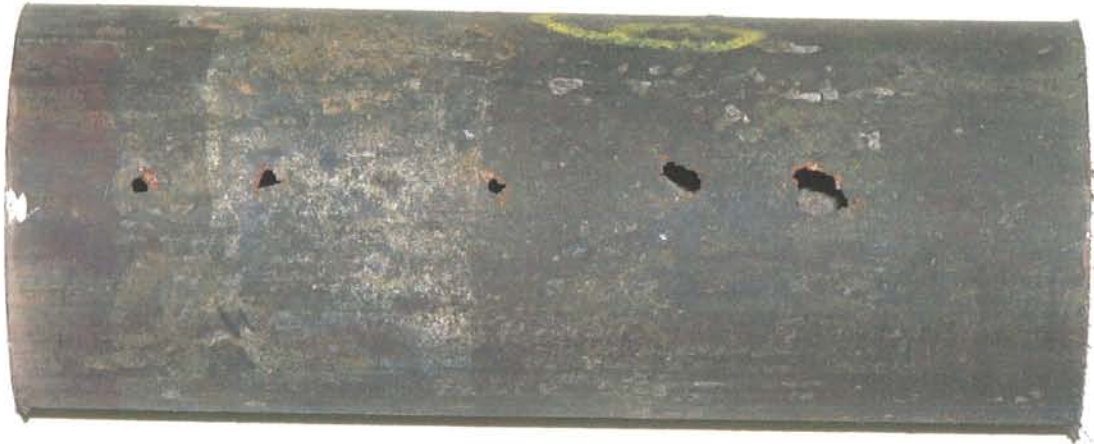
Section #6; 5,700 feet: Figure 11 shows the external surface of this section. There was a line of failure sites on the external, but no other external corrosion was noted. The section was split open to facilitate an examination of the internal surface. Figure 12 shows the internal surface of this section. There was a line of corrosion pits on one side, but no other internal corrosion was noted. The surface was coated with a thin layer of tenacious gray scale. The scale was removed and samples were collected for further analysis. Figure 13 shows the internal surface after cleaning. All of the corrosion damage was isolated to a trench that appeared to have been damaged by the sucker rod. Figure 14 shows a closer view of the corrosion. It was obvious that the corrosion had initiated from the internal surface. Most of these pits exhibited the mesa morphology that is associated with CO₂ corrosion. Some of the pits exhibited an elongated shape that is associated with a flow-induced component. There were also areas of shiny metal that appeared to be caused by the rod rubbing against the side of the tubing.

Figure 11
Section #6 from 5,700 Feet

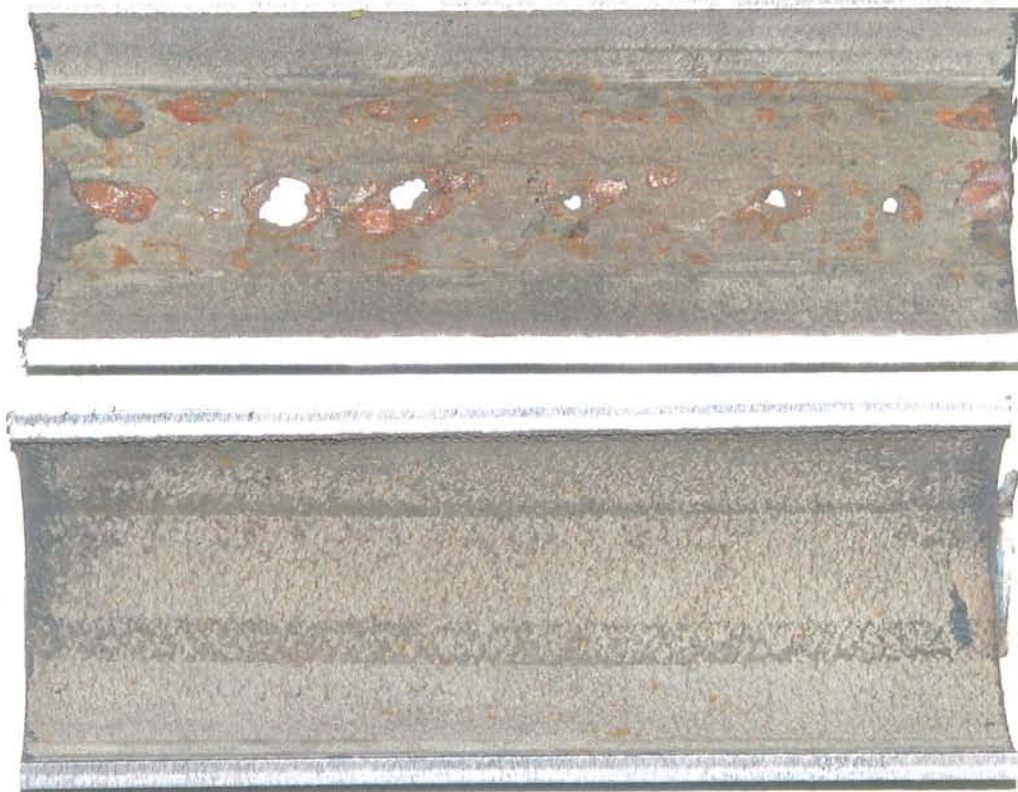
Figure 12
Internal Surface of Section #6

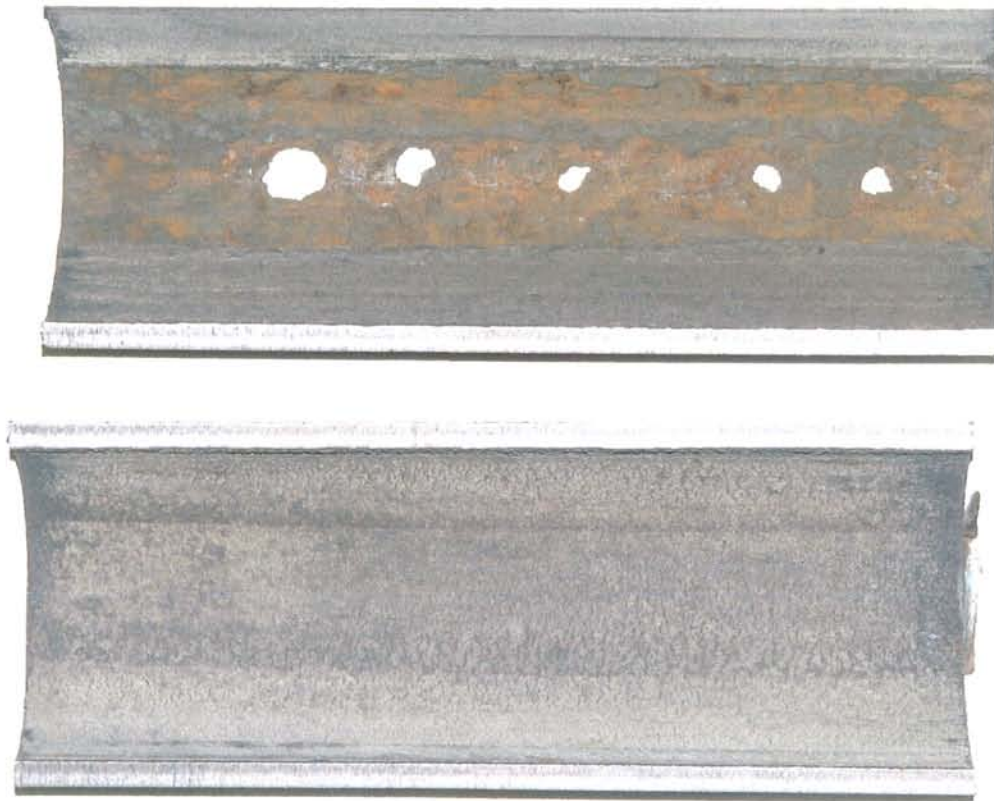
Figure 13
Internal Surface of Section #6 After Cleaning

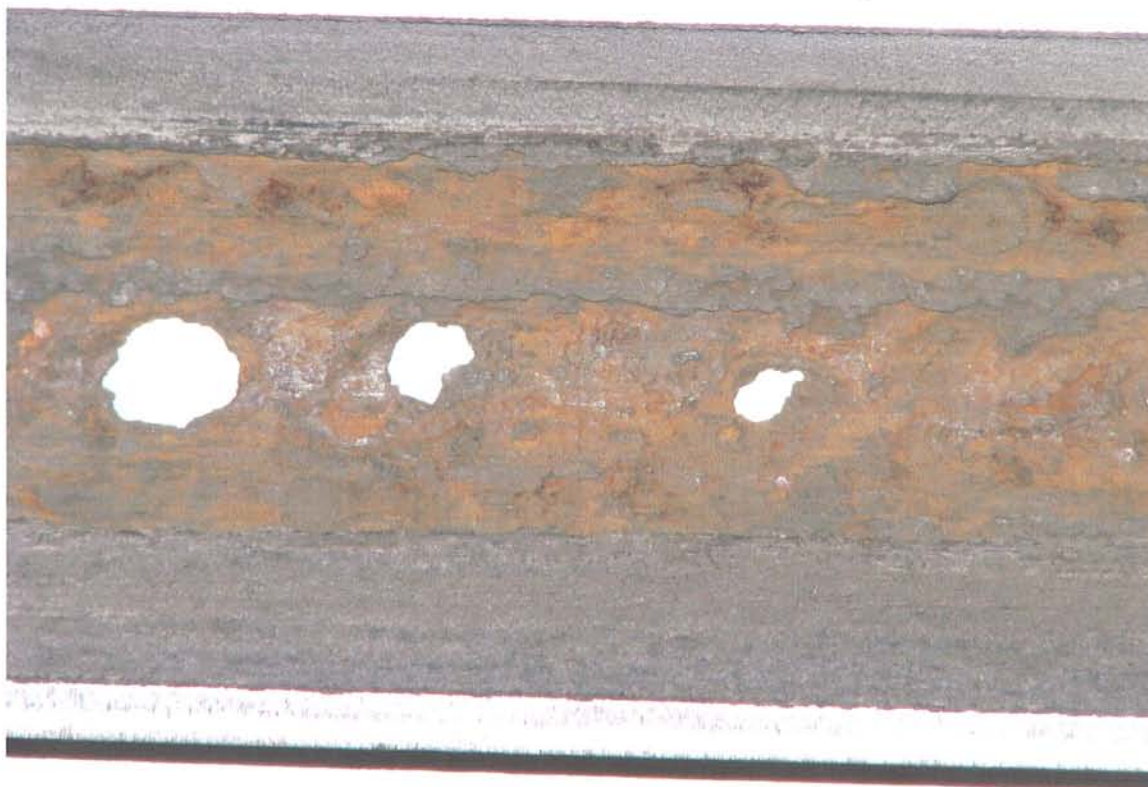
Figure 14
Internal Corrosion on Section #6

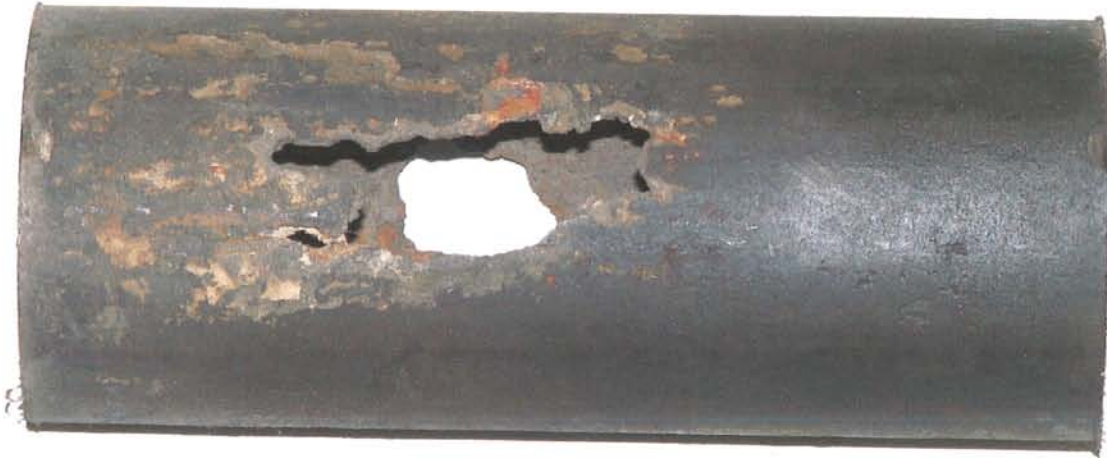
5. Several sections had failure sites on opposite sides of the tubing. The initial penetration was in the rod wear area. Once the tubing was penetrated, the flow of gas and fluids from the annulus into the tubing created an area of impingement opposite the initial failure site, which resulted in the second failure site.

Section #7; 6,800 feet: Figure 15 shows the external surface of this section. This section had two failure sites on opposite sides of the tubing. In addition to the failure sites, there was some moderate external mesa corrosion adjacent to the large hole. The section was split open and the thin layer of gray scale that was on the internal surface was removed. Figure 16 shows the internal surface after cleaning. Again, the bulk of the corrosion damage was isolated to a trench that appeared to be the result of the rod rubbing against the tubing. The second failure site was directly opposite the larger hole and appeared to be the result of fluid impingement after the first failure occurred.

Figure 15
Section #7 from 6,800 Feet

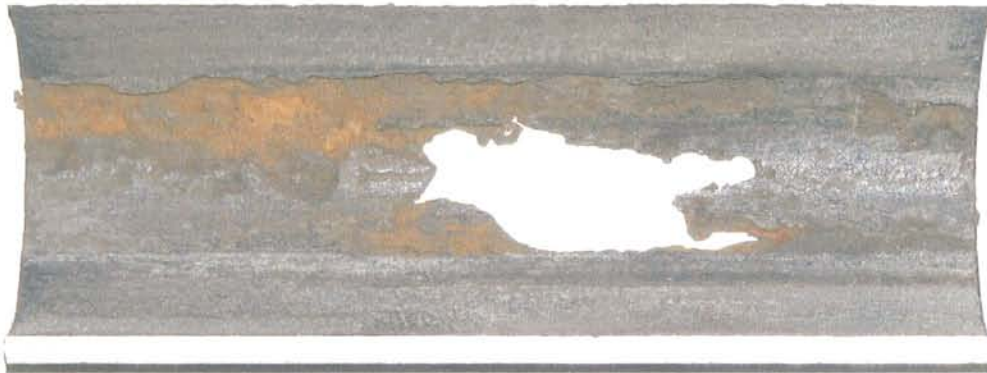
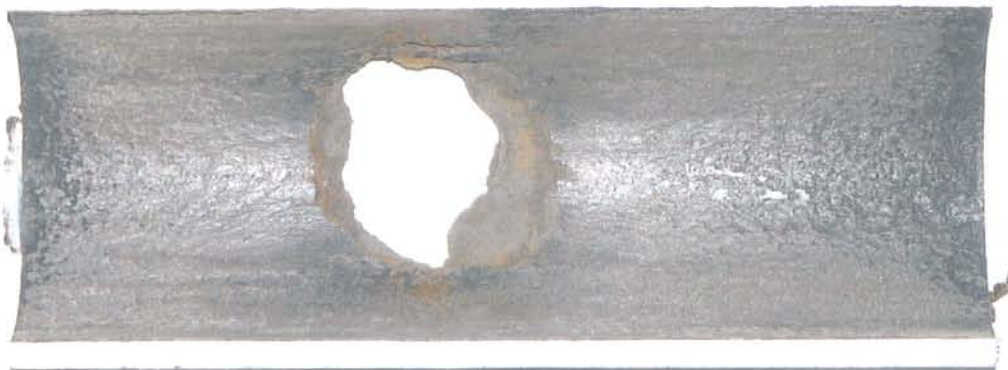
Figure 16
Internal Surface of Section #7 After Cleaning

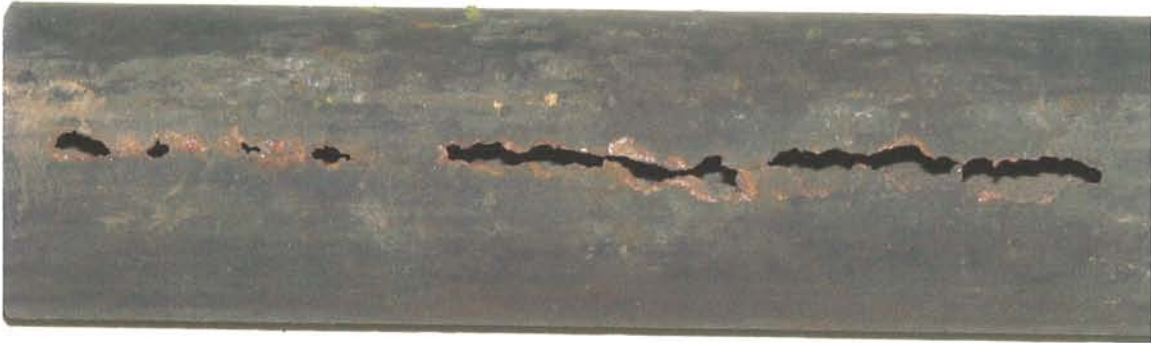
Section #9; 8,700 feet: Figure 17 shows the external surface of this section. There was a line of failure sites, but no other evidence of external corrosion. The section was split open and the surface scales were removed. Figure 18 shows the internal surface after cleaning. Again, there was evidence of rod wear and all of the internal corrosion was isolated to the trench that was created by the rod.

Figure 17
Section #9 from 8,700 Feet

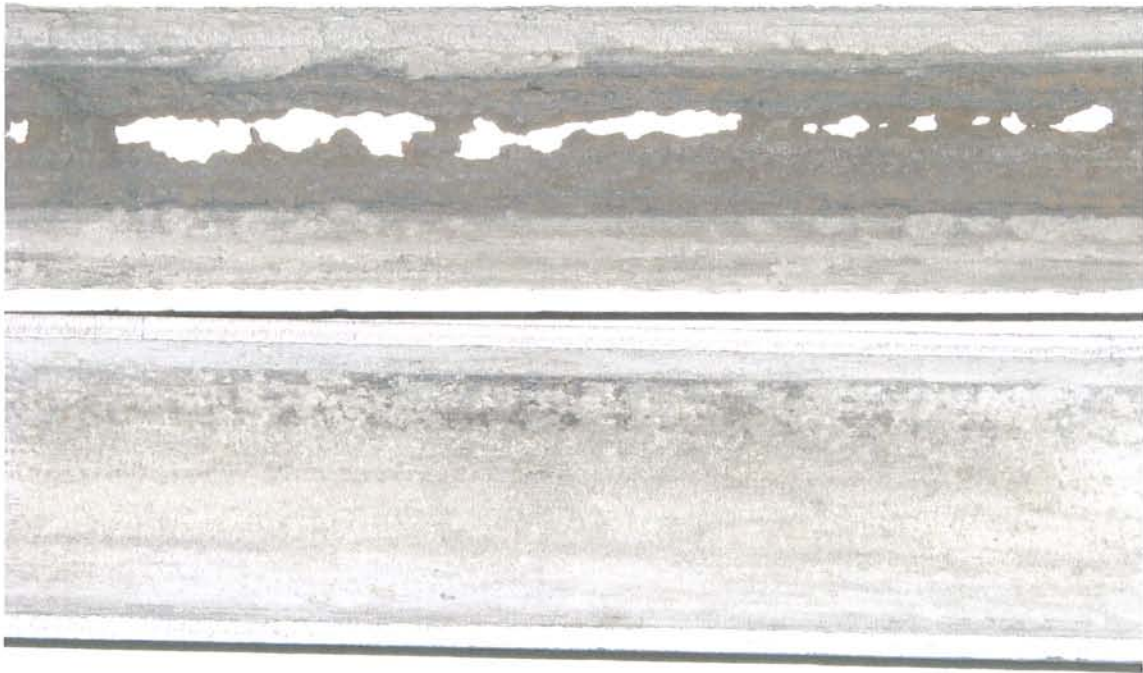
Figure 18
Internal Surface of Section #9 After Cleaning

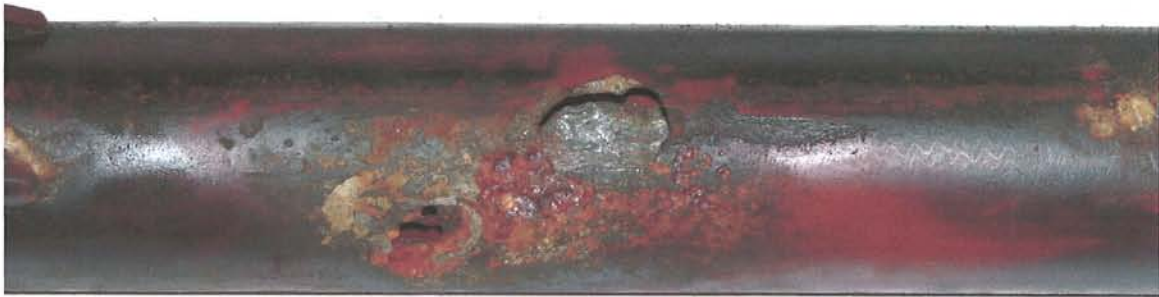
8. The two gas lift mandrels had suffered external corrosion. Again, the morphology of these pits and the abundance of iron sulfide in the scale were consistent with bacterial corrosion.

Gas lift mandrel from 3,860 feet: Figure 19 shows two very large failure sites that were present on this mandrel. The corrosion appeared to be external in origin. An inspection of the internal surface did not reveal any significant corrosion. The area around the failure sites was cleaned and samples of the surface scales were collected for further analysis. Figure 20 shows a closer view of the failure sites after cleaning. This morphology with smooth surfaces, tiered sides, slightly undercut edges, and broad flat bottoms was consistent with bacterial corrosion.

Figure 19
External Corrosion on the Gas Lift Mandrel from 3,860 Feet

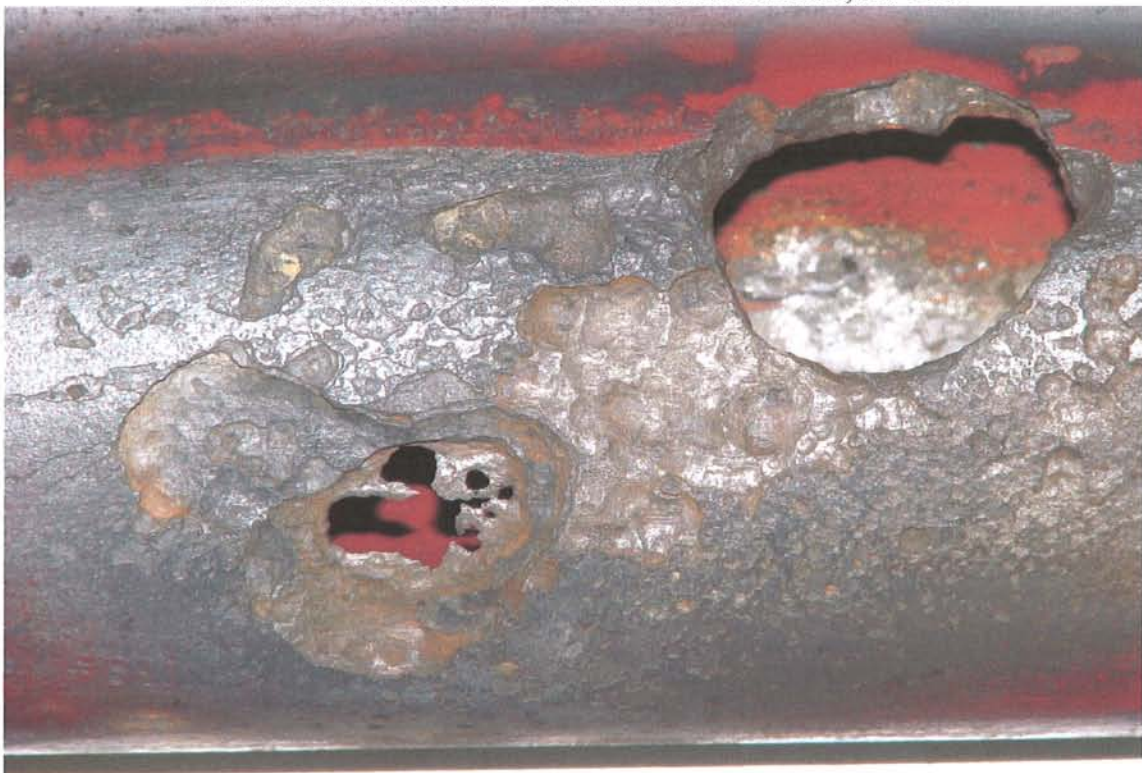
Figure 20
External Corrosion on the Mandrel

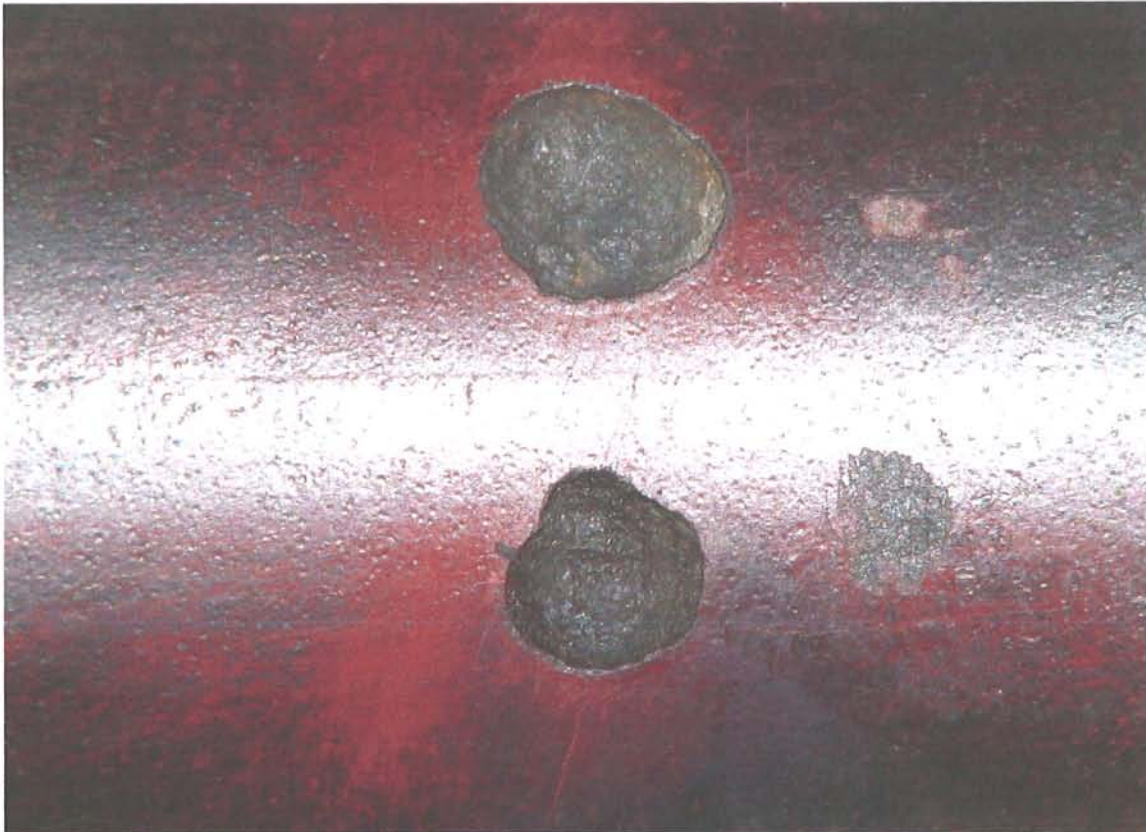
Gas lift mandrel from 4,100 feet: Figure 21 shows two deep pits that were present on the external surface of the mandrel. The failure site is shown in Figure 22. This area was cleaned and samples of the scale were collected for further analysis. Figure 23 shows a closer view of the failure site after cleaning. It appeared that this corrosion had initiated from the external surface and although there was an extensive amount of metal loss, the morphology of the pits resembled

Figure 21
External Pits on the Gas Lift Mandrel from 4,100 Feet

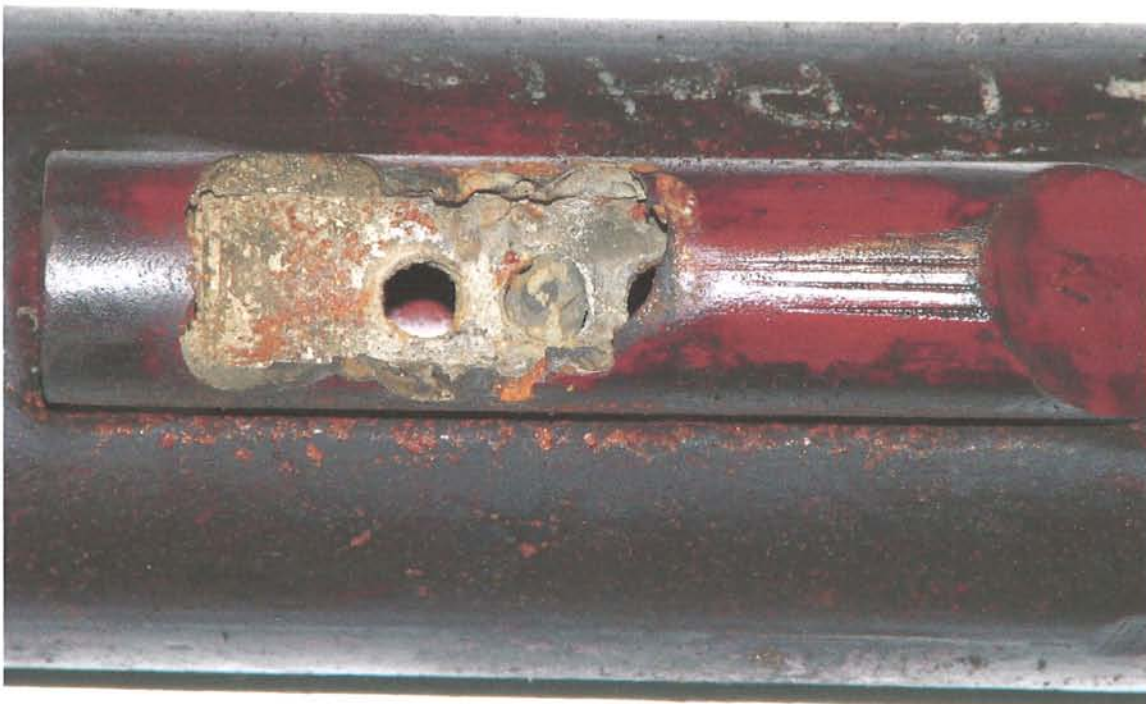
Figure 22
External Corrosion on the Gas Lift Mandrel from 4,100 Feet

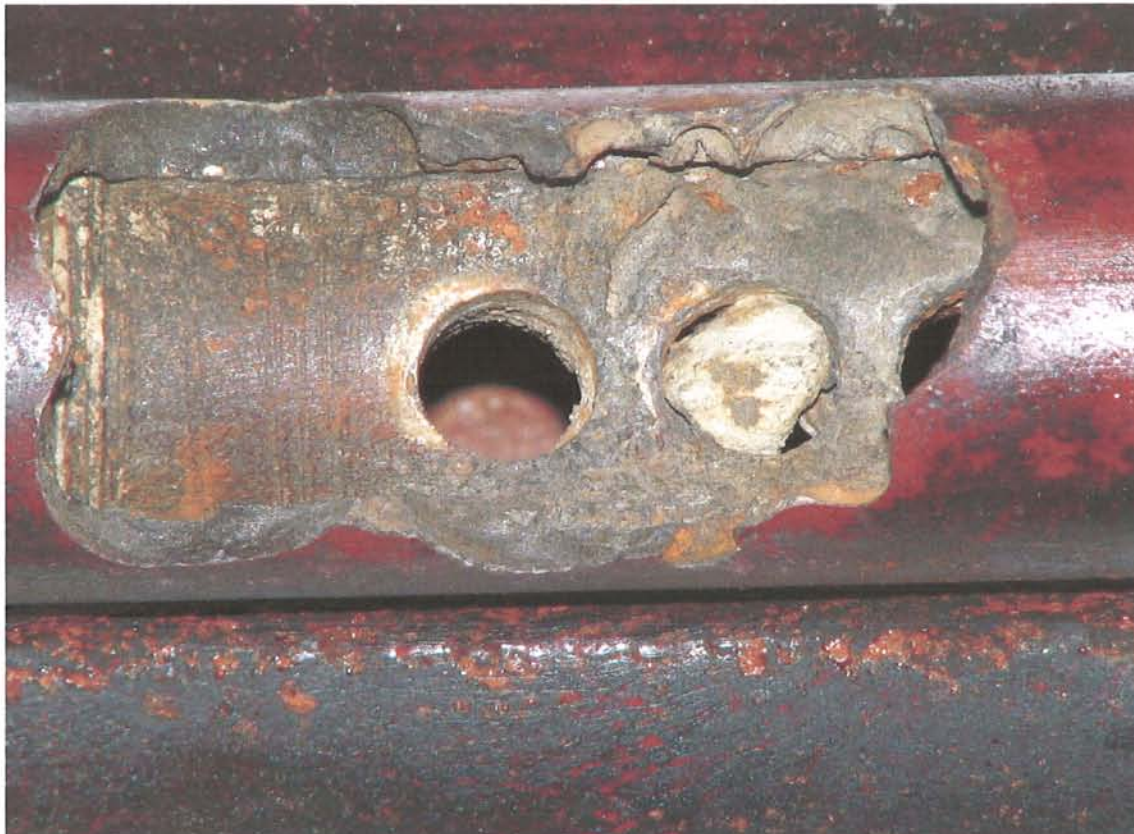
bacterial corrosion. Figure 24 shows some mechanical damage that was present on the mandrel adjacent to the failure site. It was not determined if this damage had contributed to the failure.

Figure 23
External Corrosion on the Gas Lift Mandrel After Cleaning

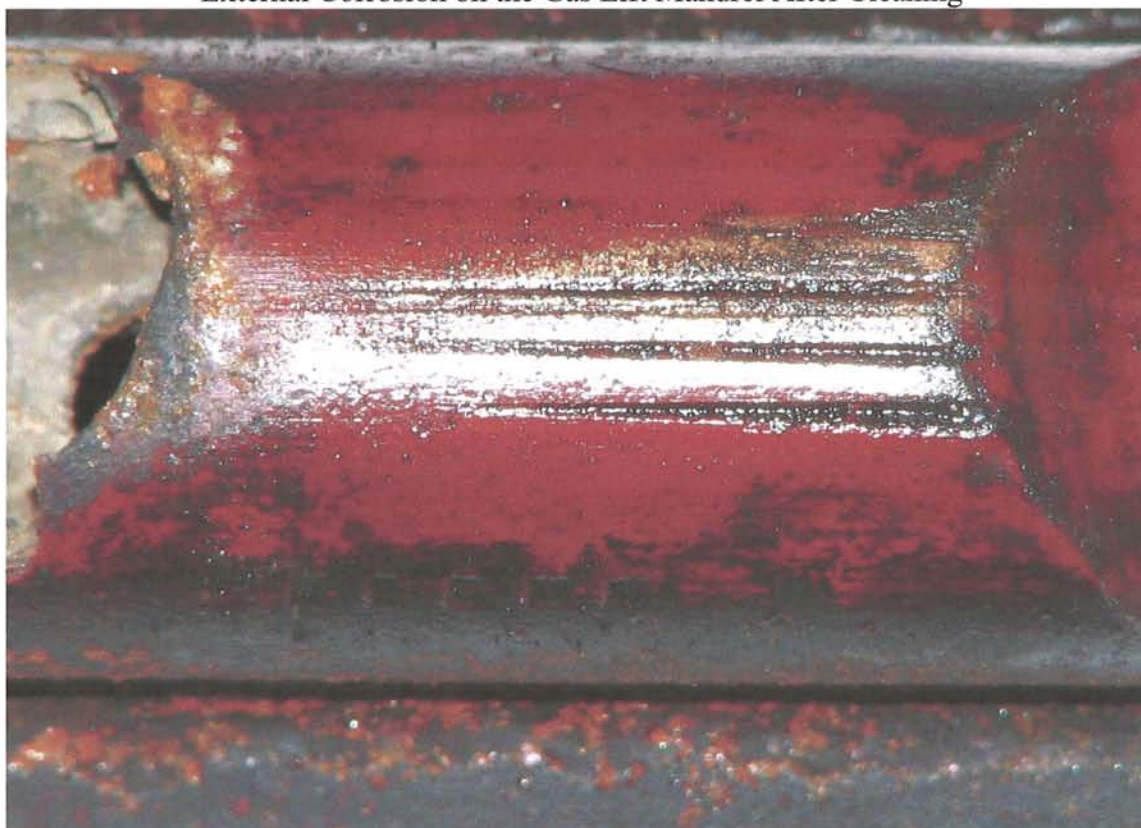
Figure 24
Mechanical Damage on the Gas Lift Mandrel from 4,100 Feet
